Flash Report on The Niigata Chuetsu Earthquake

November 2004

ABS Consulting

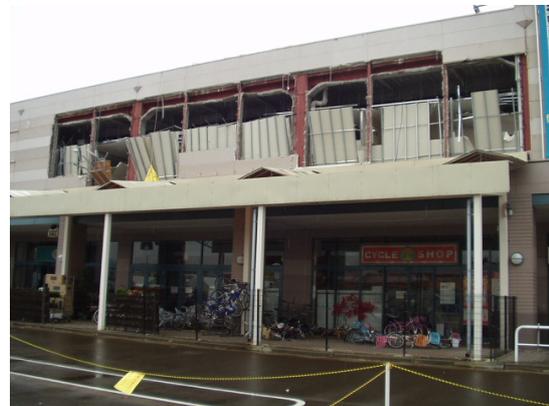
Photo O-1

Shopping center's walls facing south were dropped off (Photo O-1). It is assumed that the walls were pushed out by the swing of the ceiling. Dropped ceiling panels were also seen at the other shopping center.

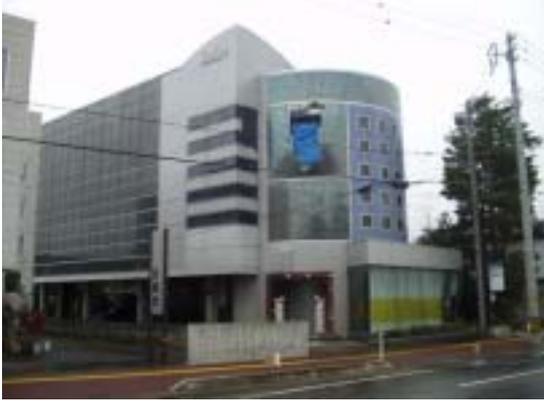
Photo O-2

The exterior materials and show window of a steel framed structure were damaged (Photo O-2). Photo O-3 shows the damage on the finishing material on a exposed column of another steel framed building.

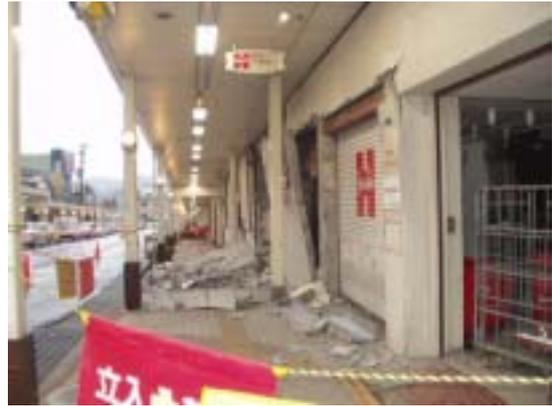
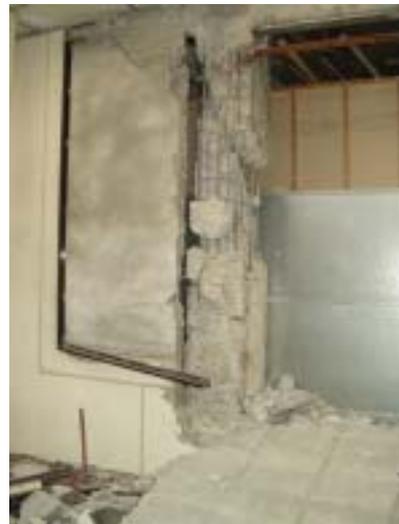
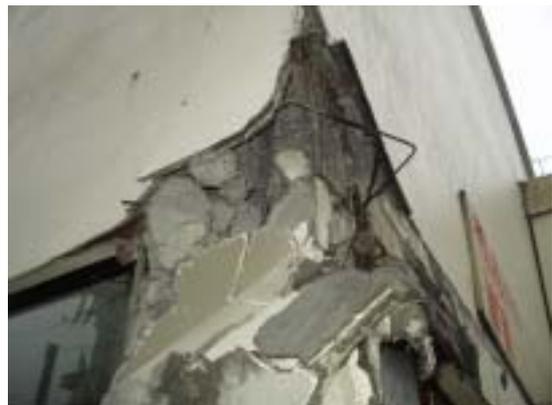
The RC buildings, which had noticeable damage, were all pre-1981 (the standards for earthquake-proof was revised in 1981). Photo O-4, O-5, and O-6 show a building in which the damage concentrated at the ground floor. A soft story at the ground floor and the lack of strength in columns could be a possible explanation of this damage. On the other hand, the building located across the street shows no damage (Photo O-7).

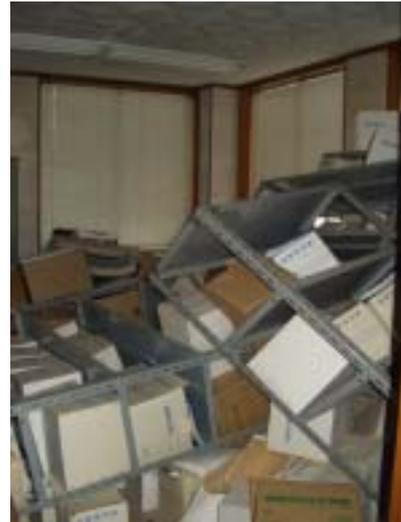
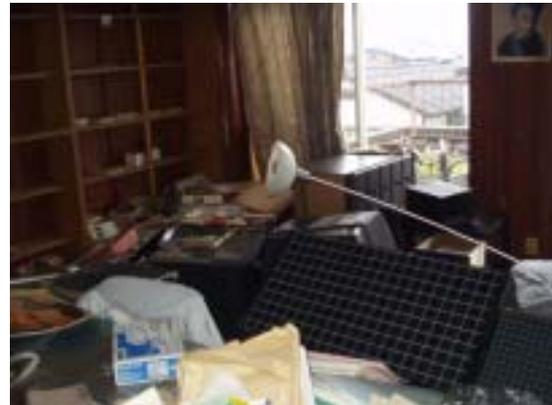
The damage inside of a building involve fall-down of furniture (PhotoO-9,10).

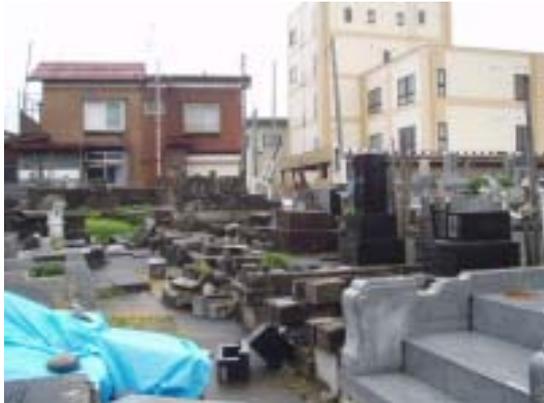
Photo O-8

At the cemetery, gravestones were falling towards east and west (Photo O-8).

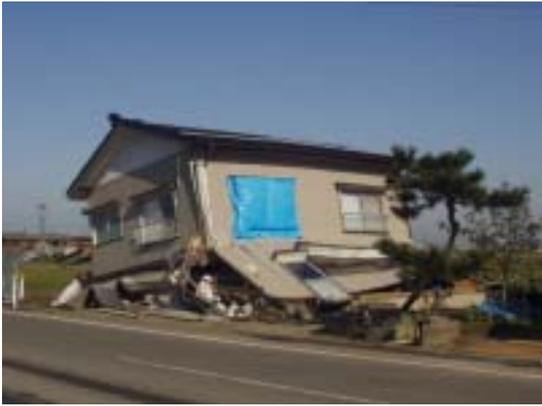
Photo N-1 shows the soft ground area. Settlement and cracks on the road were extensively seen. Differential settlement caused some buildings to collapse. Photo N-1 shows a building which ground floor used as a storage area was collapsed due to the insufficient amount of walls.

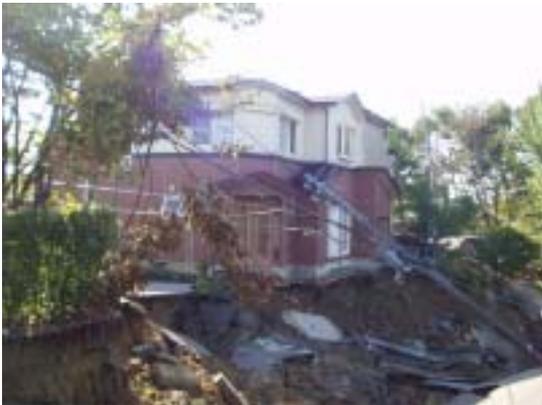
Takamachi Danchi showed in Photo N-2 is a relatively new housing complex area developed in a shape of tableland. The edges without retaining walls experienced landslides that had the road break and fall. 2x4 construction and wood panel construction dominated this area. While those house located at the edge experienced severe damage, those houses at the center part of the area showed minor damage.

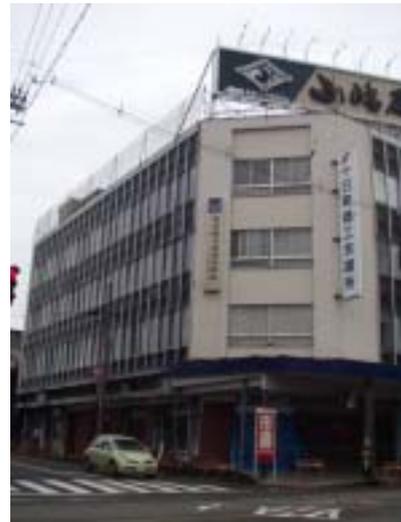
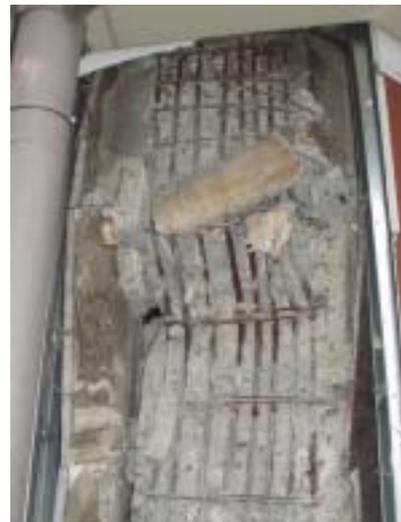
The severe damage on RC structures was noticed at the center of Tokamachi-city (Photo T-1, 2, 3, 4). On the other hand, damage on wooden structures was relatively small. This difference

probably comes from the characteristics of a seismic period of ground motion.

Photo T-2 shows the damage on a column of an RC building, and Photo T-1 shows the whole figure. The interval of hoop bars was 30 cm. The building located across from Photo T-1 also experienced shear failure in a column at the ground floor (Photo T-3, 4).

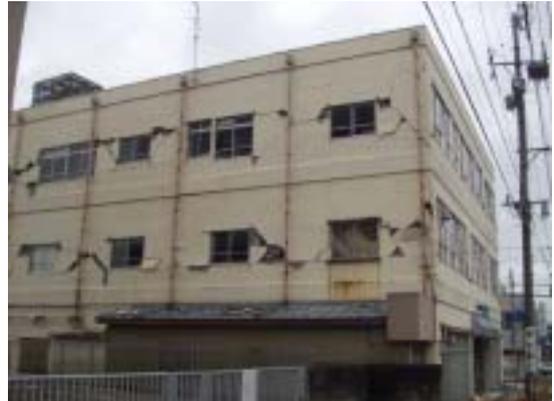
Photo T-6

A concrete block structure (CMU Wall structure) shows severe damage in Photo T-6.

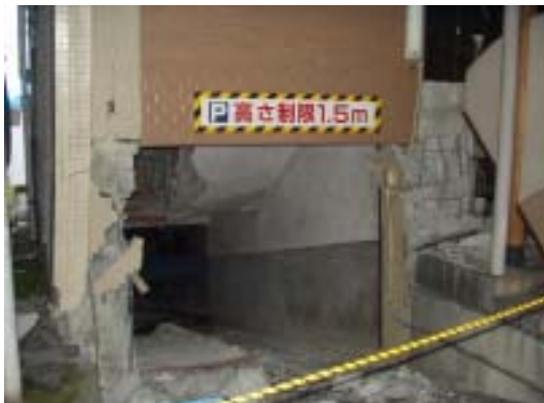
Photo T-5 shows the damage occurred at a short column formed by a hanging wall.

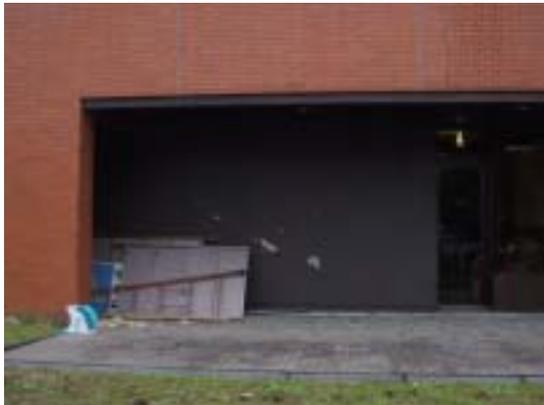
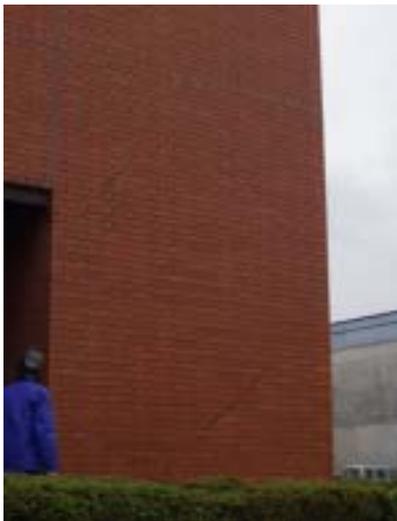
Photo T-9 and T-10 show a building constructed after 1981. An RC wall had a shear failure.

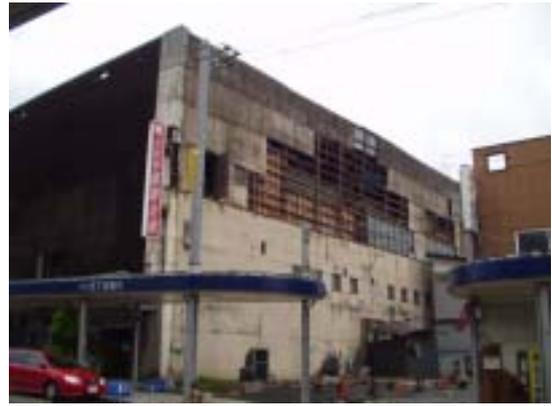
Photo T-11

Old steel structures experienced drop-off of the exterior walls (Photo T-11).

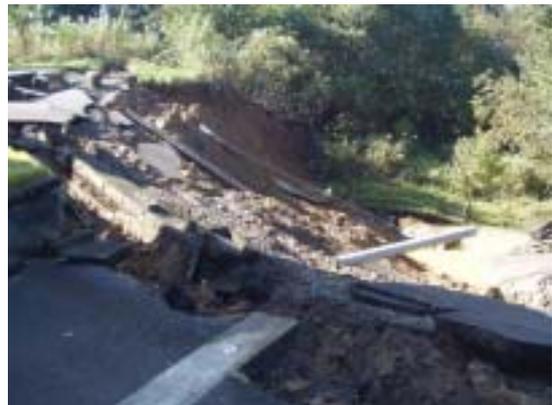
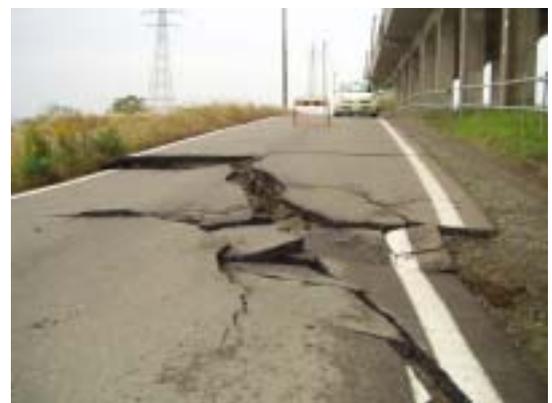
A number of settlement and cracks on roads and landslides occurred and caused closures at many locations (Photo I-1, 2). In Nagaoka-city, a large landslide crashed into the route 589 (Photo I-3) and ripped the road down to Shinano River.

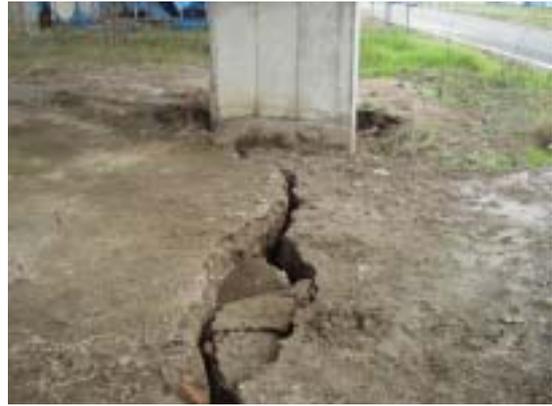
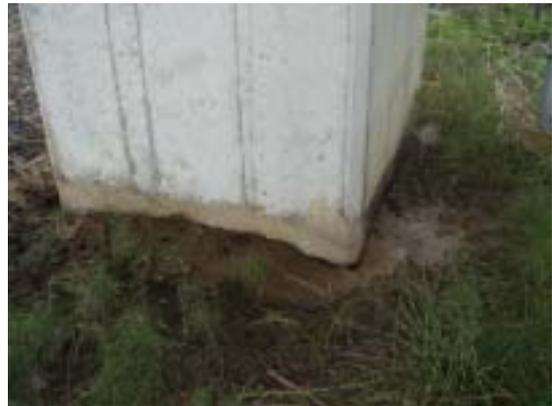
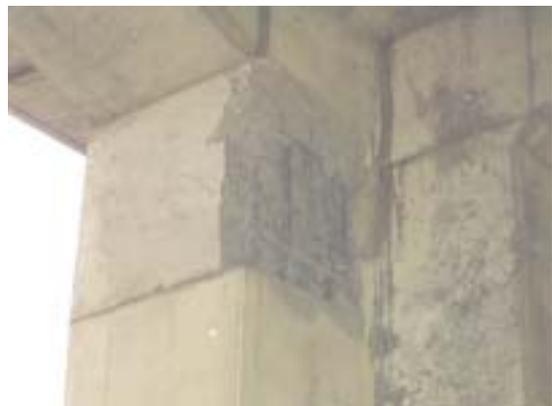
Shinkansen (bullet train) was derailed at Nagaoka-city, and it was the first derailment in the long history of Shinkansen. The piers of Shinkansen were affected as showed in Photo I-5, I-6, and I-7. Other railroads were also closed due to settlement of the ground, bent rails, or tilted poles and signals.

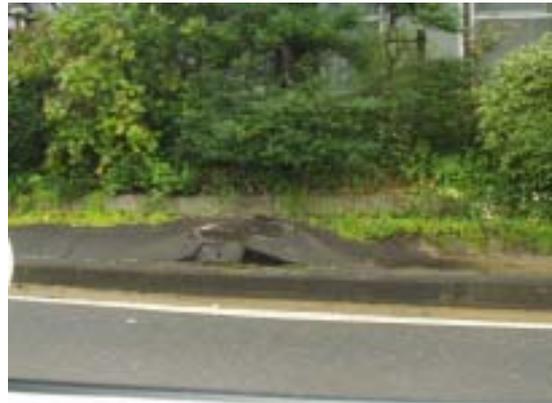
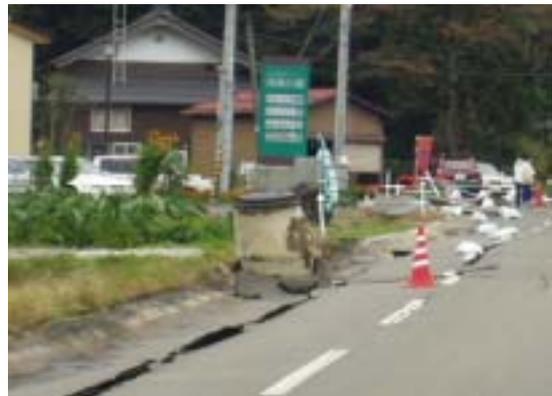
Manholes at many locations were floated up by liquefaction (PhotoL-1, 2).
