Flash Report on The Niigata-ken Chuetsu-oki Earthquake

Summary of the Niigata-ken Chuetsu-oki Earthquake

On July 16, ABS Consulting sent two structural engineers (Mr. T. Ogawa and Ms. M. Ozawa) to the affected areas in Kashiwazaki-city and Kariwa-village for three days to investigate the damage caused by the earthquake. The areas marked 'X' in the Figure 1 show the locations investigated.

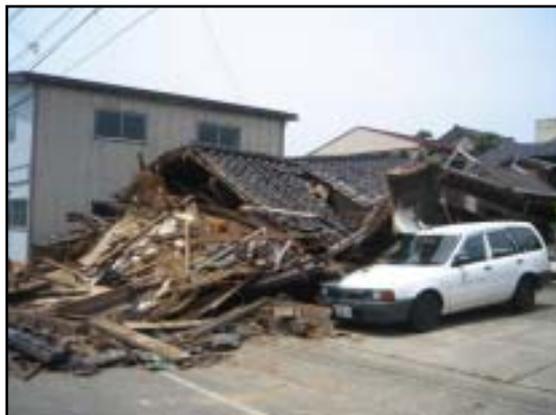
Photo 1

The collapsed houses were mostly old wood buildings. The traditional heavy black roofing tiles, which are typically in the Northeastern costal areas of the Sea of Japan, were used on the traditional and old wood houses. Many of the roofs retained their shapes even if the other parts of the houses completely collapsed (Photo 1). The roofs are traditionally constructed using a thin layer of clay to keep the tiles in place. However, the clay is likely used more for insulation purposes since Niigata has cold and snowy winters.

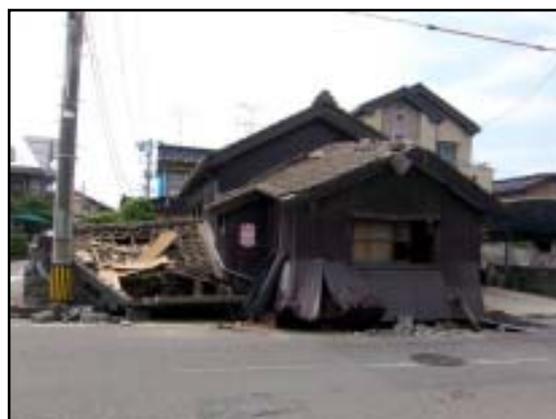
Photo 2

There were many examples that showed that the first story of houses collapsed when the level had many window and door openings while the second story of the same houses maintained its shape and integrity (Photo 2). After the 2007 Noto Hanto Earthquake, similar damage patterns were observed in wood houses.

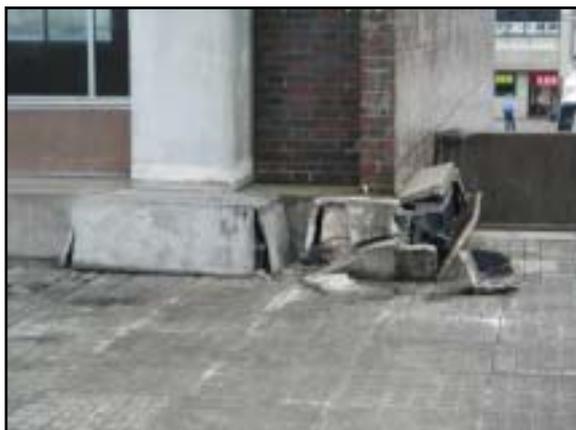
Photo 3

Reinforced concrete buildings in the urban areas were also damaged. At the Kashiwazaki-city office building some of the columns were found to be damaged (Photo 3). On the second-story parking level of a big supermarket, a water tank was found to have suffered damage (Photo 4).

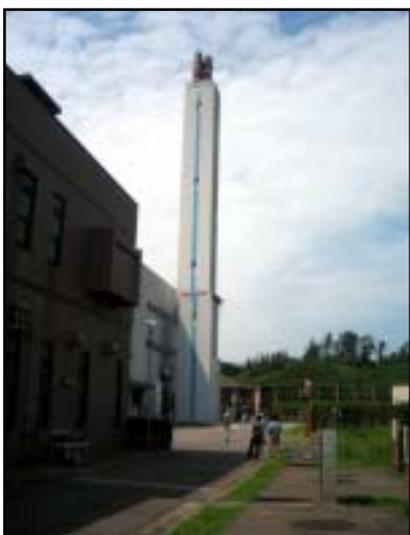
Photo 5

Furthermore, at the Kashiwazaki-city's rubbish incinerating facility a 59 meter high by 4.6 meter wide reinforced concrete exhaust chimney was found broken stretching vertically for 10 m long, at slightly below the center of the chimney (Photo 5). Based on the condition of the protruded reinforcing, the chimney broke at the lapped reinforcing joint (Photo 6).

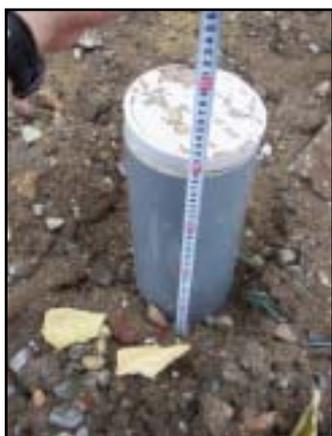
Photo 7

The General Affairs Office in Nishiyamacho Kashiwazaki-city is located in the middle of this mountainous area. It appeared to have received relatively little damage during the earthquake. However, the pipes in the surrounding area were found to protrude about 400 millimeters above the ground level, which was probably caused by the change in ground level by the earthquake ground motion (Photo 7).

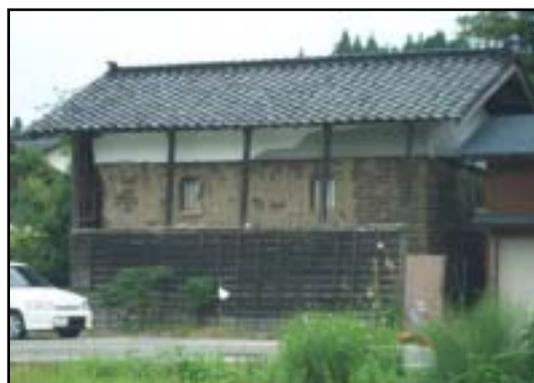
Photo 8

In the same area, many warehouses are constructed with walls made of mud and it was found that many of these walls had peeled off (Photo 8).

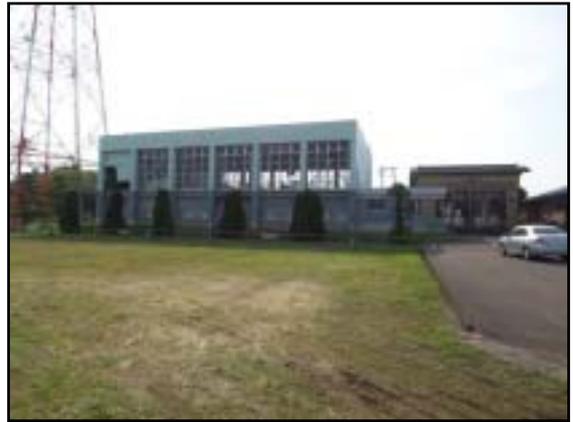
Photo 9

Gymnasium of Katsuyama Meeting Hall (Photo 9) is a reinforced concrete building, which suffered damage at the column-girder joints (Photo 10), broken windows, fallen ceiling panels (Photo 11), fallen external cladding and broken steel braces (Photo 12). Although the meeting hall had not collapsed, it will take a long time to restore it to its original state. Likely, the lateral forces induced by the earthquake were much greater than the design forces. No braces were seen in the ceiling system during our inspection. In recent major earthquakes, the inadequate strength of ceiling systems in large spaces was noted.

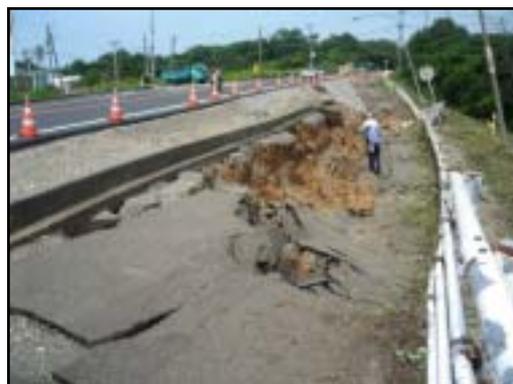
Photo 13

The National Highway Route 8, 116 and 352 passing through Kashiwazaki-city and Kariwa-village had many cracks, uneven surfaces and ground subsidence. Route 8 passing through Kujiranami Kashiwazaki-city was especially badly damaged with a 100 meter stretch of its embankments slipping more than two meters (Photo 13).

Due to rapid repairs, the National Highways were open to traffic quickly and were soon fully functional.

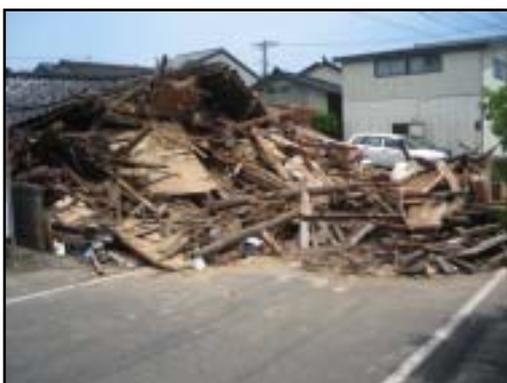
Photo 14

The roads across the city were found to be damaged and had cracks and uneven surfaces in many places. It was also observed that many of the collapsed wood houses along these roads had blocked the road access (Photo 14). Many of the overpasses over rivers had subsided near the bridge abutments, which impeded traffic (Photo 15).

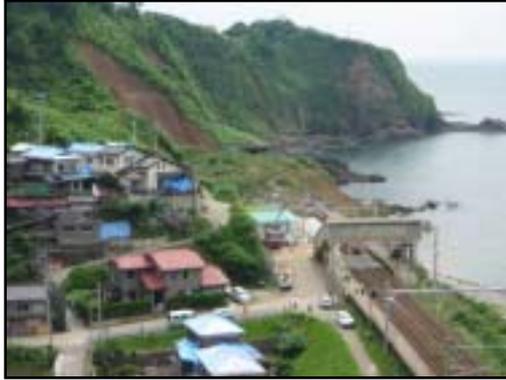
Photo 16

At JR Shinetsu Mainline's Oumigawa station, the largest earthquake induced landslide happened (Photo 16). The heavy rains during the previous day by Typhoon 04W (Man-Yi) may have contributed to this landslide. The landslide caused a large amount of soil and stones from the steep hill behind the railway station to be washed into the nearby coastline. Part of the railway lines and the station's platform were completely buried under the debris. Fortunately, there was no one injured by the landslide. Since there are many steep hills around the JR Shinetsu Mainline's Oumigawa station, there were many similar large landslides (Photo 17).

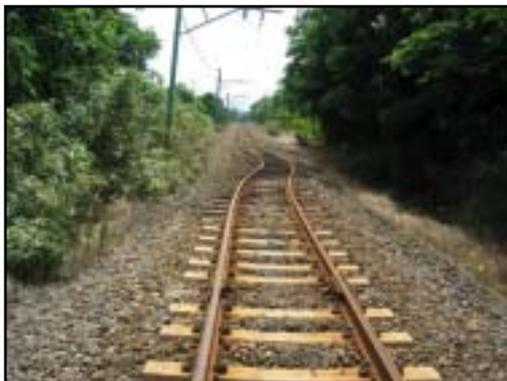
Photo 18

Between Arahama Street and Nishiyama Street on the JR Echigo Line, the rails were found to have deformed in several places due to soil deformation. The most seriously bent rails were bent approximately 800 millimeters (Photo 18).

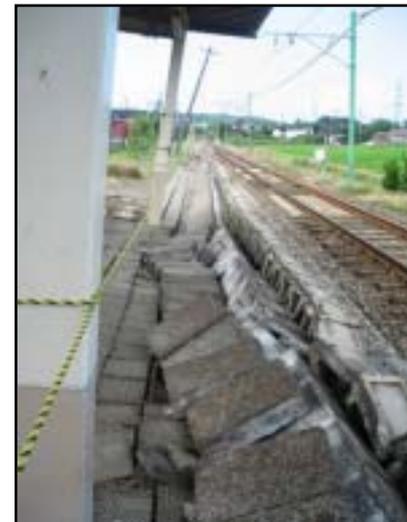
Photo 19

The Arahama station's platform was also completely damaged (Photo 19).

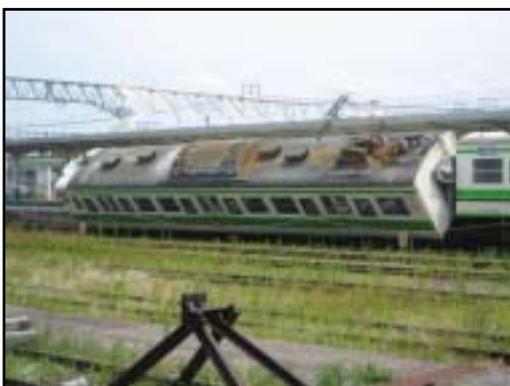
Photo 20

One train car of a two car train on the Echigo's line was stopped at the JR Kashiwazaki Street platform and was derailed by the earthquake (Photo 20). At the time of the earthquake, the train car held one railway worker and two passengers. Fortunately, the earthquake injured no one.

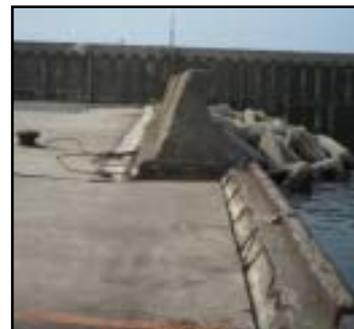
Photo 21

At the west wharf, settlements of the embankments opened joints in the aprons and deformed the ground in the yard area behind the banks (Photo 21). The embankment settled 200 millimeters and moved 500 millimeters from the bank's edge towards the sea.

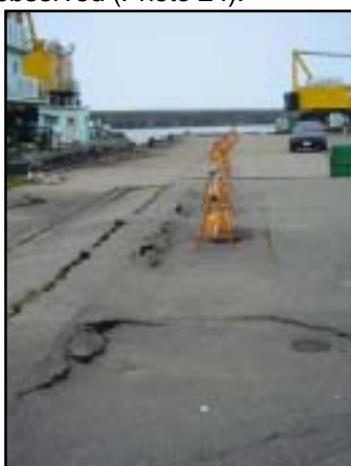
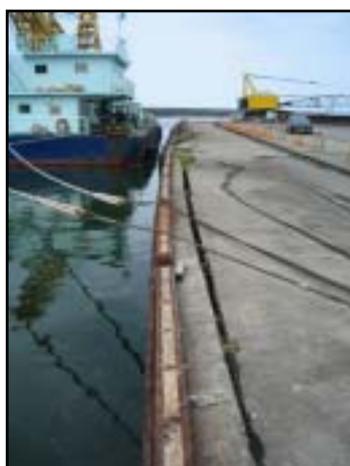
The central wharf area had cracked asphalt, deformed quay walls and uneven surfaces (Photos 22 and 23). Also, in many places around the harbor remains of blown-out sand caused by liquefaction were observed (Photo 24).

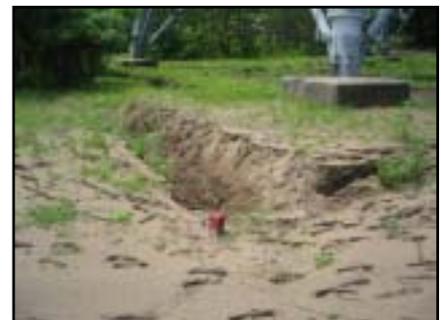
Photo 25

The earthquake caused many locations of boiling sand in Kashiwazaki-city and Kariwa-village due to liquefaction (Photo 25). Manholes and sewerage pipes raised out of the ground (Photos 26 and 27). According to the National Geography and Crustal Dynamics Research Center, the Kashiwazaki urban area is located between the Yoneyama mountain district and the Nishiyama hill region. The area contains alluvial soils

where the sand deposits have flown from the rivers over the soft alluvial formation. These soil profiles were the prime reasons for causing liquefaction to happen in many locations during the earthquake.

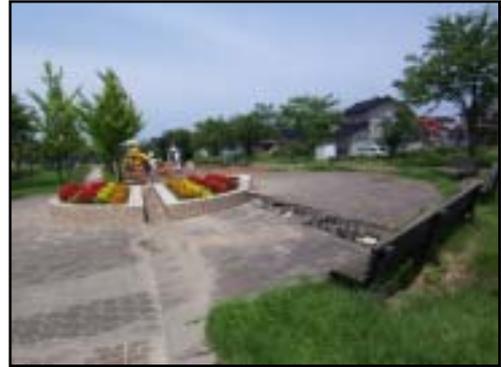
Photo 28

Considerable liquefaction was observed at the Suidobashi Park in Nishimotocho Kashiwazaki-city (Photo 28). This area was transformed into a park during the flood mitigation effort in 1984 when the Ugawa river system was straightened.
