Flash Report on The Niigata Chuetsu Earthquake

November 2004

ABS Consulting

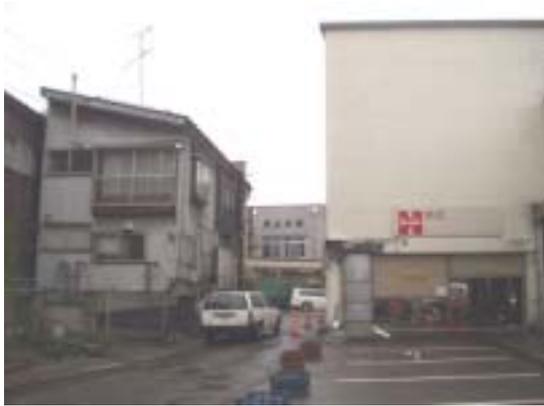
Photo O-7

The RC buildings, which had noticeable damage, were all pre-1981 (the standards for earthquake-proof was revised in 1981). Photo O-4, O-5, and O-6 show a building in which the damage concentrated at the ground floor. A soft story at the ground floor and the lack of strength in columns could be a possible explanation of this damage. On the other hand, the building located across the street shows no damage (Photo O-7).

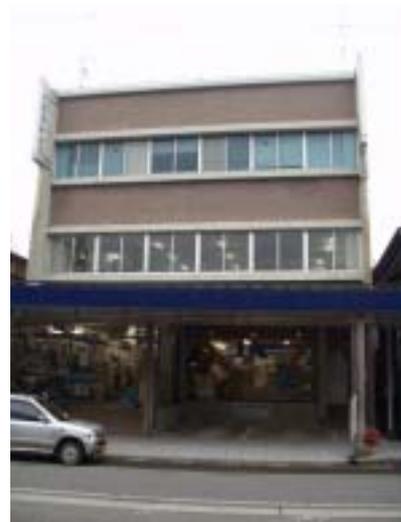
Photo T-7

A reinforced building in the city center showed no noticeable damage. The show window was not affected at all (PhotoT-7,8).

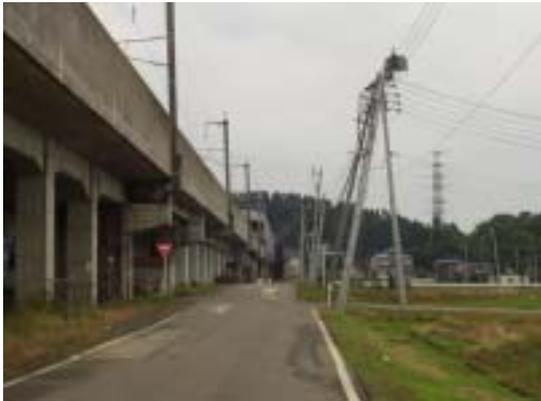
Photo I-8

According to Niigata Prefectural Government, on 23 October, 278,000 houses experienced blackout due to the damage on electric poles and

lines. Even after three days from the main shock, some areas were still suffering from blackout.
